# RIO TINTO

## Safety Notice 2002-A-19

**Date** 10-May-2002

**Classification** A - Safety Alert

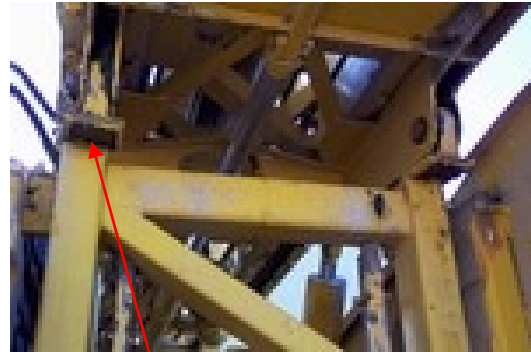
Both the second pivot point mountings have failed at the weld joint. The welds appear to be the original welds from manufacture and show the following:-

- 1/ Lack of fusion
- 2/ Lack of penetration
- 3/ A large amount of porosity in the weld material
- 4/ Corrosion cracking running from the inside of the welded joint through to the porous

material.

The above problems would be consistent with the welds having a lack of shielding gas during the welding process, and is evident on both welded mountings. An amount of moisture has been able to penetrate the porous weld which has caused the welds to rust and induce corrosion cracking around the inside edges of the weld. These cracks have caused stress raisers in the weld material and allowed these cracks and porosity to combine, until they weakened the joint sufficiently to induced the failure.

**Remedial Action** The internal investigation is continuing. Representatives from the drilling contractor will make further assessments in consultation with the manufacturer.
