## **1. BACKGROUND INFORMATION**

At approximately 11.45 hours on Friday 30<sup>th</sup> November 2001, an incident involving a drill rig UDR 650#1 occurred. The rig was performing Reverse Circulation (RC) drilling and following standard procedure.

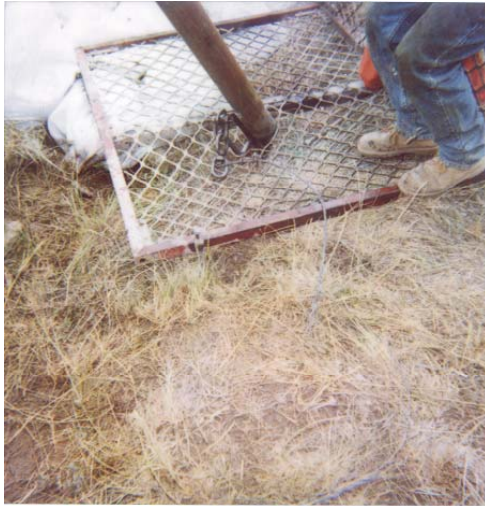
The incident occurred when the wire rope attaching the clamshell to the hook broke causing the drill rod to slide through the clamshell and fall to the ground. The offsider had hold of the handle on the hook which dragged him down as the rod fell causing him to strike his head against the drill rod. As he collapsed, he also knocked his right knee on a metal guard on the ground.

The drill rod came to rest against the mast having fallen onto the metal mesh spin-guard which was placed on the ground while running rods – Figures 1 & 2.

**Figure 1.**  
Metal mesh guard on which off-sider struck knee. Lifting hook with handle still in rod end, failed wire rope and swivel attached.

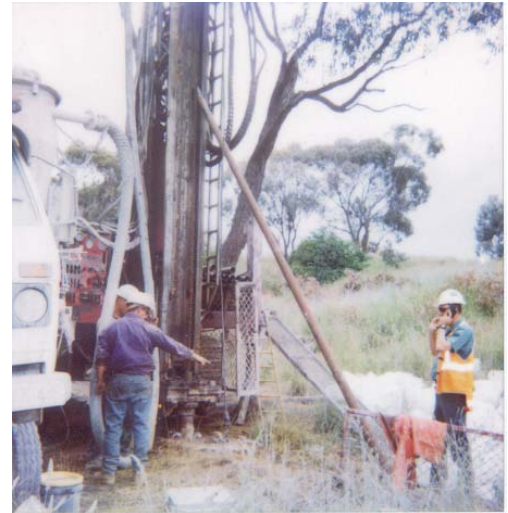
**Figure 2.**  
Drill rod leaning against rig mast, end 'speared' into metal mesh guard. Clamshell and main winch at top (7/8) position on rod.

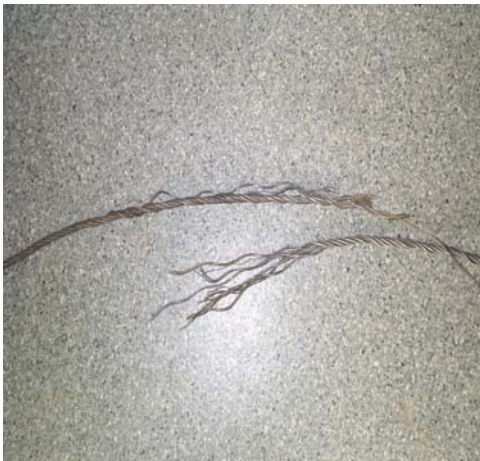
- The wire rope was 8mm, 6 strand (each of 6 finer strands), right hand wound, ‘spinning’ cable rated to 10,325lb or 4.61 ton for a steady lift - Figure 3.

- This cable is intended for use as the wire line rope on (diamond) drill rigs and not as a lifting cable for RC rigs although the practice of using the readily available wire line rope on multipurpose rigs is common.

- As the main winch is capable of exceeding the rating of the wire rope, and as no torque limiter was fitted to that rig, it is likely that at some stage the hook or clamshell has been caught on something momentarily causing a tensional force in excess of the wire rope rating. This is plausible but not definite in the opinion of the crew.

- The use of ‘spinning’ wire rope instead of ‘non-spinning’ rope will cause the cable to unravel or bird-nest when subjected to high tension (sudden jamming etc).

- An initial ‘jamming’ may have caused a minor internal failure of one or more of the fine strands which could have propagated with repeated use; the external appearance of the cable would not show obvious signs of the ‘bird-nesting’ internally.

- A slight jerk of the main winch while running the rods would be enough to cause sudden catastrophic failure, this is quite likely (and unavoidable) when conducting rod handling exercises.

**Figure 3.**  
8mm diameter, 6 strand wire cable showing tensional failure.

- Immediately replace the wire rope with 6 tonne rated, high tensile chain and shackles to suit on all rigs requiring attention. COMPLETED 30<sup>th</sup> November.
- Replace the two swivels with one equally rated swivel. COMPLETED 30<sup>th</sup> November.
- Install torque limiter on drill rig UDR650#1 (UDR 650#8 and UDR650#2 both have torque limiters fitted). TO BE COMPLETED by 7<sup>th</sup> December.

- Discontinue the practice of using wire line cable; use either 'non-spinning' cable or high tensile chain.
- Ascertain safe working load rating of UDR manufactured 'clamshell'.

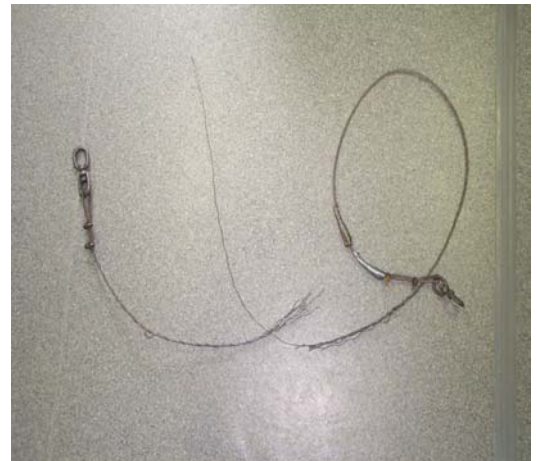
- The wire rope was fitted with swivels at both ends as opposed to a single swivel at the clamshell attachment (usual set-up) – Figure 4.
- The drill rod was a 4” diameter x 6 metre long Medski rod of approximately 159kgs.

**Figure 4.**  
Lifting 'rope' showing failure and twin swivel set-up.
